Dental Follicle

Scientific Editorial: Orthodontic And Prosthodontic Interdisciplinary Approach For A Smile Makeover

Separated File removal with a Ultrasonic file removal kits aided by operating microscope literature review and a study of 2 cases

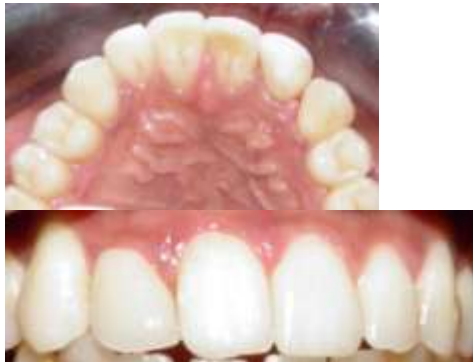
The crown preparation was done and a metal free zirconia crown was cemented .The final arch form (fig 6) was acceptable and the patient was pleased with the outcome of the

treatment (fig:7). The problem was resolved by limited orthodontic treatment followed by full coverage zirconia crown.

Fig 6 : The Final Arch Form Fig 7 : The Zirconia Crown Cemented to Tooth No.7

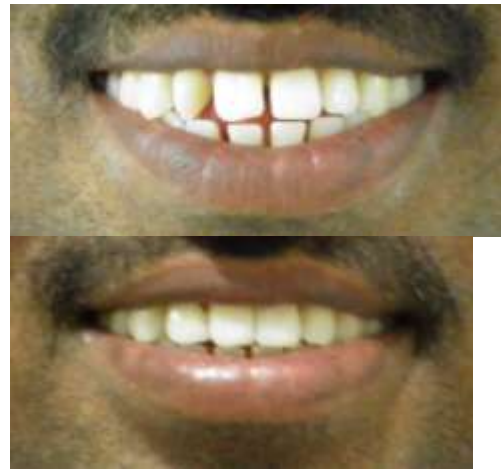
Fig 8 and 9: The Pre And Post Treatment Smile

Interdisciplinary, multidisciplinary and comprehensive treatment plans are now part of everyday practice ¹. The dentist has to be skilled to deliver such complex treatments. Precise orthodontic and restorative treatments must be carefully coordinated in the treatment plan to ensure final aesthetic outcome. (fig 8 and fig 9)

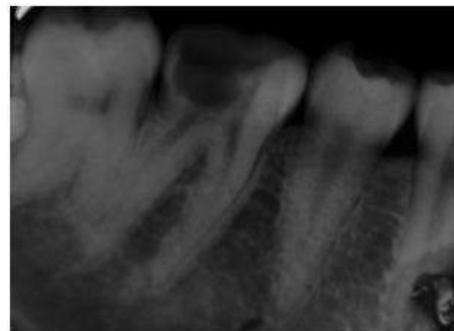
Figure 1

A patient was referred with the issue that a Protaper file was fractured in one of the mesial canals of a lower first molar. Two intra Oral Periapical X ray Film was sent along with the patient. Figure1 and Figure2.

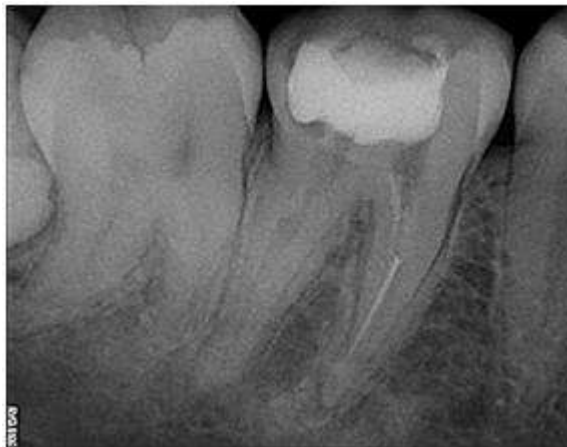
Figure 3

An additional RVG radiograph was taken to confirm file position. Figure 3.

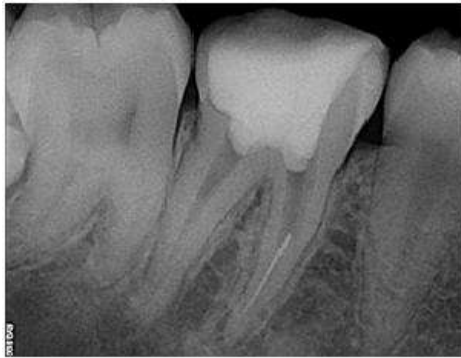
After a platform was created in the root dentin around the instrument a long tipped Dentsply Start X no 3 TM was used to ditch around the fractured file fragment. After considerable ditching was done, it was decided to call the patient for a second appointment. Calcium hydroxide was placed in the canals and a ball of cotton was placed in each of the canals and Cavit G TM was placed inside the pulp chamber. His occlusal level was checked to make the tooth out of occlusion. A second x ray was exposed. Figure 4

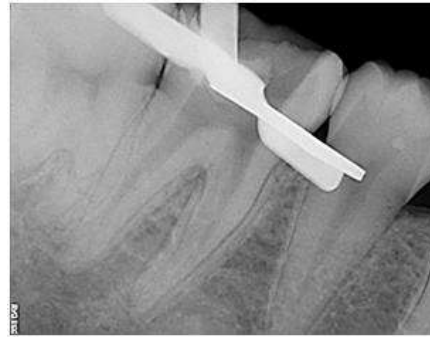
Second sitting – In the second sitting again the patient was anaesthetized and a rubber dam was placed. The CaOH was flushed out with saline and 17% EDTA as mentioned before. After drying the canal the file was again visualized and the Dentsply Start X ultrasonic tip number 3 TM was used around the instrument to ditch around it. At a time when the “deep reach” of the start X was inadequate then the Satelac Endo success kit TM was used to continue with the retrieval attempts. First the ET 20 was used in a anti clock wise direct around the broken file. When the “deep reach” was no more when the ET 25S was used in an anti clock wise direction and finally the ET 25 tip was used in an anti clockwise all around the instrument. The ultrasonic vibration was sent along the length of the file by wedging the ultrasonic tip between the dentin wall and the file⁶. This completely loosened the file fragment and it came out easily out after that. Figure 5

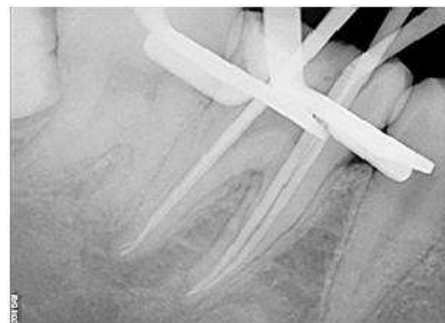
All the canals were instrumented with 2 % files to patency and after achieving a glide path a step back to a size 30 was done. Maintenance of working length was constantly checked on an apex locator. After a step back the final finishing of the canals was carried out with 5% Flare files up to a size of 30 in all 4 canals. A cone fit X-ray was taken which showed that the fine medium Gutta Percha was over extended in the Mesio lingual canal it was adjusted to a size of 40 diameters at the tip. Figure 6

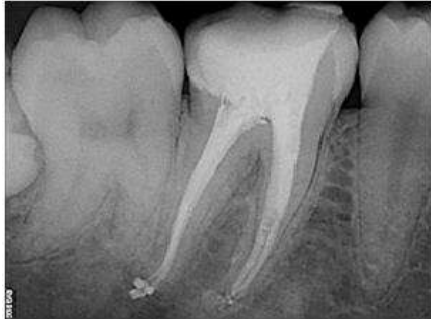
Figure 7

minute each. The canals were coated with AH plus sealer TM and then down packed with an E & Q plus Master pen TM. Next the canals were back filled with thermo softened Gutta Percha and condensed with Gutta pluggers. Then cavity space was packed with Cavit G. Figure 7.

Root canal filling up of all space inside the canals was seen in the x ray.

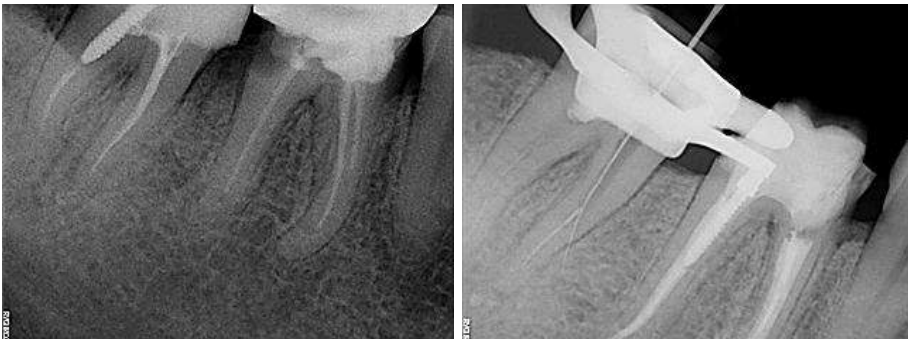
Figure 8, 9,

The case showed below shows incompletely treated lower right first and second molars. Figure 8. The lower right second molar has a

root canal filling which has a broken instrument embedded inside the mesio-lingual root canal filling of the second molar. The tooth has periapical radiolucency on both roots. Figure 8. In an attempt to remove the broken file a perforation had been caused in the mesio-lingual canal by the referring dentist. Figure 9. The Gutta percha was removed the apex was reached through the confluent mesio buccal canal. The perforation was sealed with MTA leaving the separated file in place. Figure 10. During the subsequent visit with the canal filled with hypochlorite passive ultrasonic irrigation with Satelac Irrisafe TM was carried out. That was followed up with 50% Citric acid and 17% EDTA. It was during the PUI in the mesio buccal canal when the fragment shown below came out without any conscious attempt to take it out. Figure 11. Root canal filling of the canals was done with apical down pack and coronal backfill with warm vertical condensation of Gutta Percha. Figure 12
